Broseley Bell Ringers

Bell Restoration Project

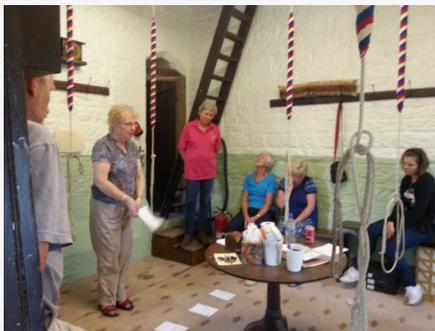
Our bells are regularly maintained, but are in need of some more substantial work. The issues include:

- Worn pulleys need replacement
- Some of the wooden sliders have been repaired with metal and require replacement.
- The layout of the bells on the frame is not ideal. Ropes don't fall vertically from the bell to the ringer. There is also some 'pinching' of the bell fittings as the frame flexes.

We intend to send the bells to the bell foundry to remove the crown staples. The bells will also be retuned to make them sound more harmonious as a peal of eight.

In the meanwhile, the frame will be replaced with one that provides a better layout. It will also have capacity for an additional two bells, giving someone the opportunity to donate a bell either now or in the future.

The bells will then be hung in the new frame with new fittings.

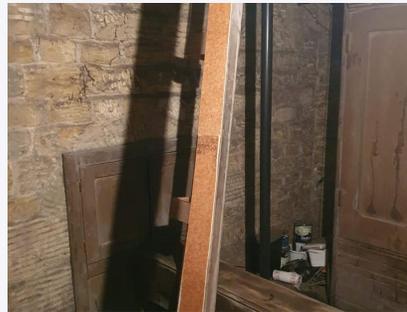
- Bearings and gudgeons have not been refurbished for some time, increasing the risk of them failing.
- Bells 3 to 8 originally had iron crown staples welded to the bell metal which held the bell to the original wooden headstocks. The remnants of these could cause stress in the metal, possibly causing the bells to crack in the future.
